## STRUCTURAL SAFETY INSPECTION REPORT FORM

**1. DESCRIPTION OF STRUCTURE**a. Name on Title: Four Story Residential Condominium Apartment Building with 56 Units (Application #: 1026122)b. Street Address: Lyndhurst H, Deerfield Beach, FL 33442c. Legal Description: Lyndhurst H Condo Unit 1001 PER CDO BK/PG: 5907/1d. Owner's Name: Lyndhurst H Condominium Association, Inc.e. Owner's Mailing Address: 2101 Centrepark West Dr., Suite 110, West Palm Beach, FL 33409f. Email Address: lyndhurst.h@yahoo.comContact Number: (647) 409-1893g. Folio Number of Property on which building is located: 4842-03-DH-0010h. Building Code Occupancy Classification: Residential Group R-2i. Present Use: Residentialj. General Description: Four Story Residential Condominium Building Type of Construction: III-Bk. Square Footage: Approx. 81,600SF (Google)Number of Stories: 4

**ELECTRICAL SAFETY INSPECTION REPORT FORM**

# Lyndhurst H Deerfield Beach, FL 33442

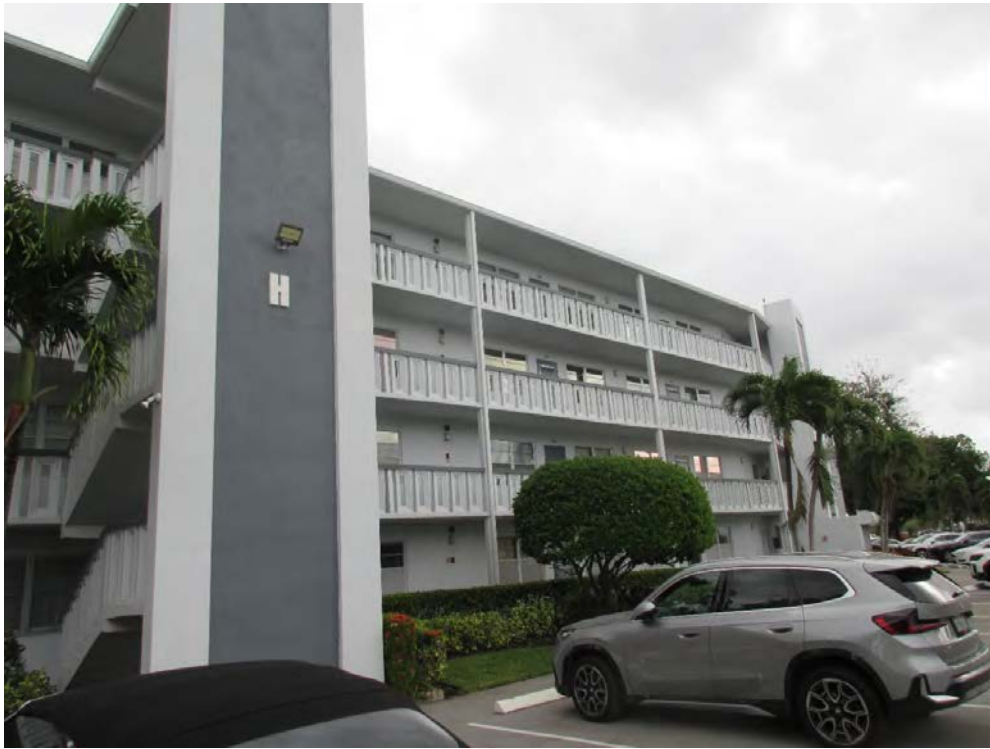
2. Present Condition of Overall Structure

No beams, columns, structural walls, or floors were noted to be under visible distress upon inspection.

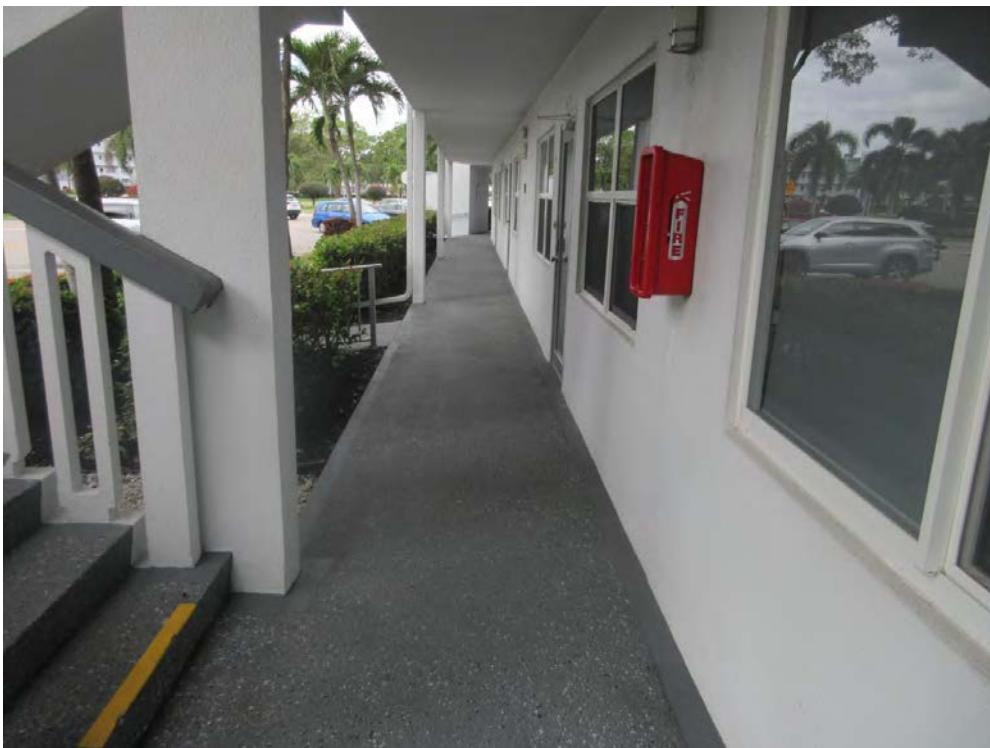
2.c. View of Surface Conditions

Surfaces are in good overall condition, consisting of decorative stucco with a painted finish.

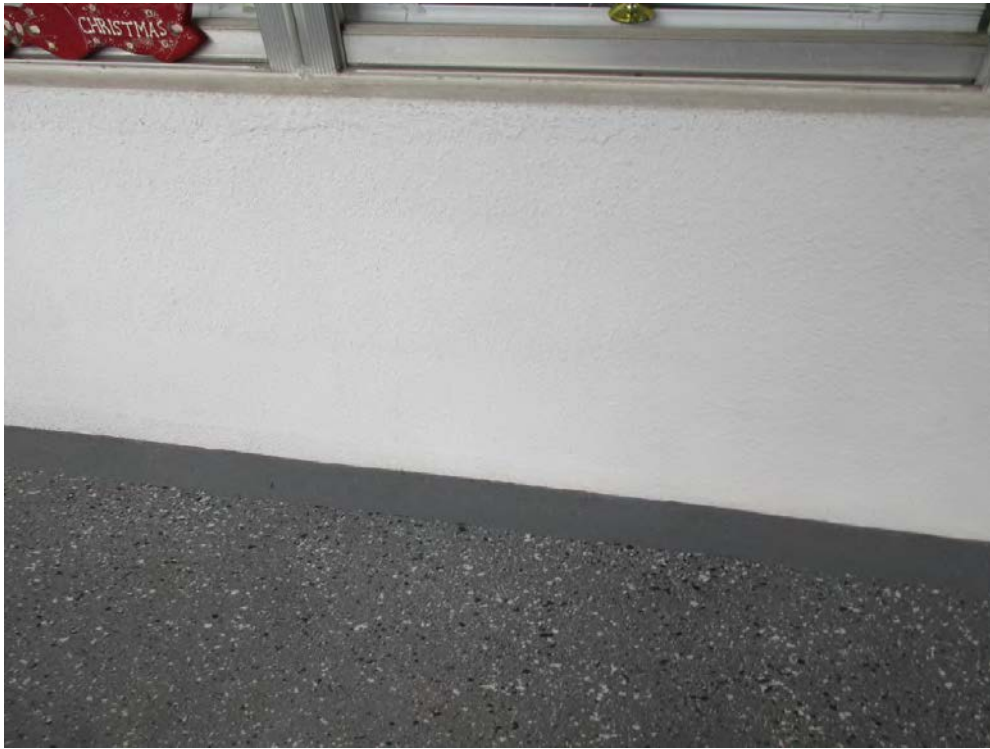
5. Building Foundation - Uniformity

The reinforced concrete vertical structure is reinforced concrete slabs on grade (SOG) construction. The exterior walls are supported by reinforced concrete continuos footings.

No discernible cracks or separation in the walls, columns, or beams that signal differential settlement were identified.

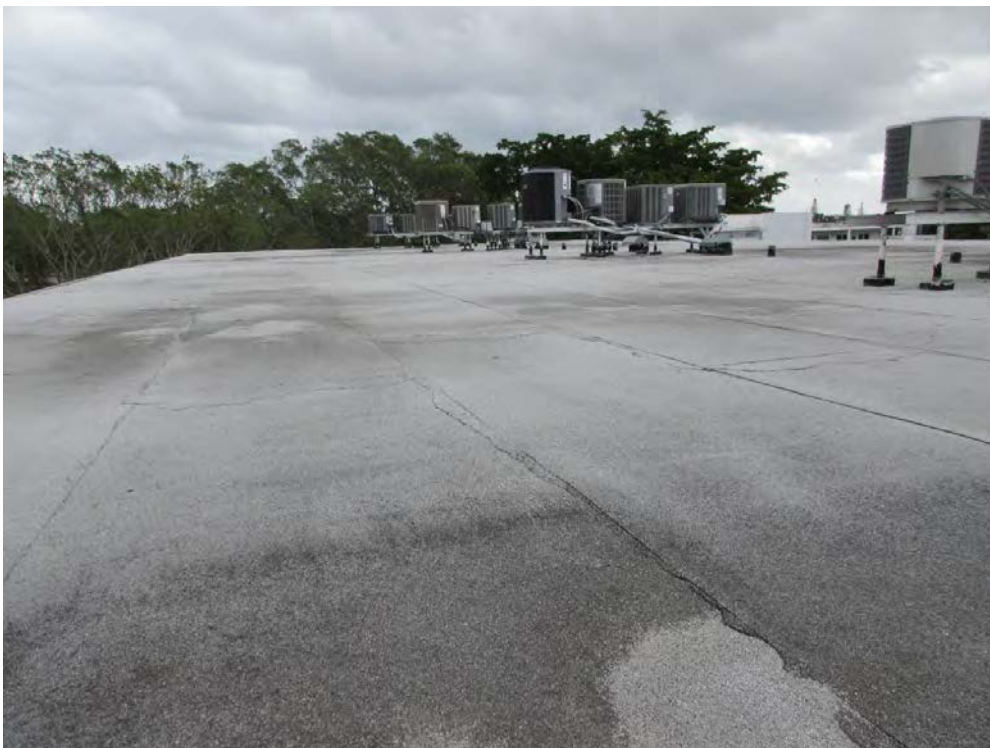
7.a.1. Type & Condition of the Current Roof

The low sloped flat roof is constructed of reinforced concrete and is finished with built-up roofing materials (BUR) and has a modified bitumen roof covering with silicone spray foam. Noted to be in good condition. No significant leaks were identified and any issues should be addressed as a part of routine maintenance.

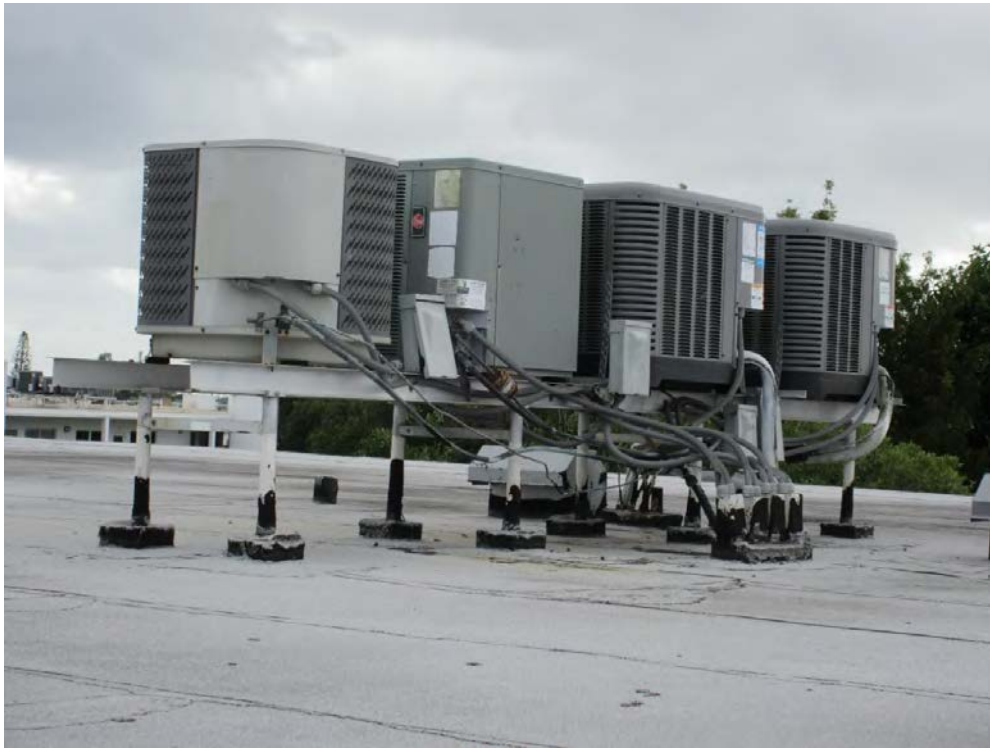
7.a.2. View of Air Conditioning Equipment/Other:

Typical split system condenser units mounted on elevated metal stands. Noted to be in good condition.

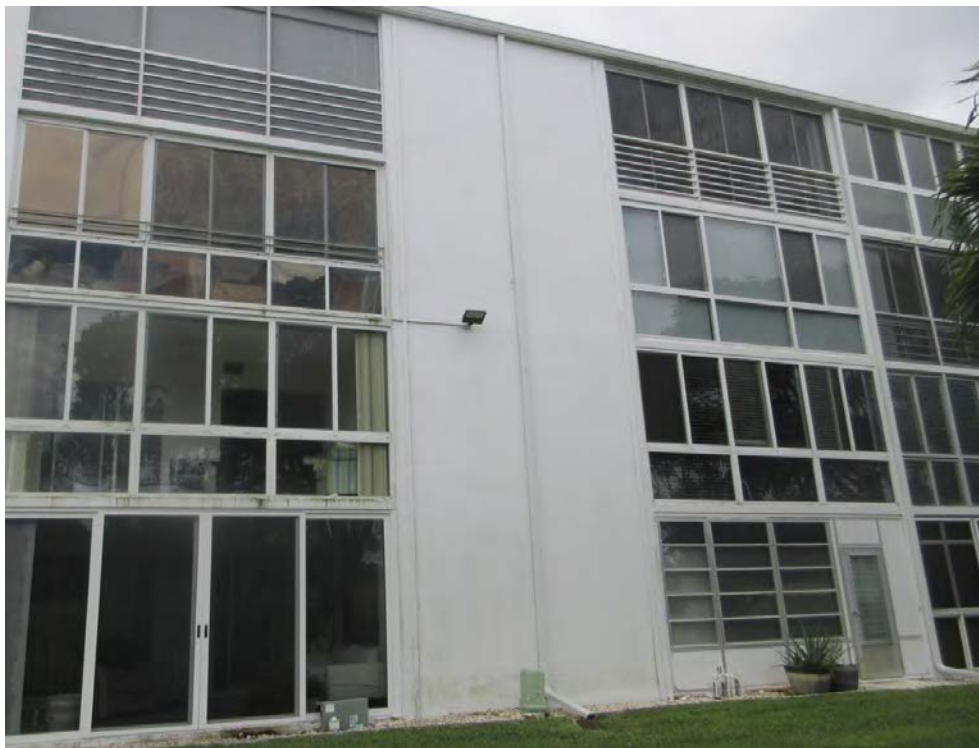
7.a.3. View of Roof Drains, Scuppers

The low sloped flat roof is pitched to the roof drains and the run-off is mitigated by scuppers and downspouts. Roof drains, scuppers, downspouts and drainage were noted to be in good condition.

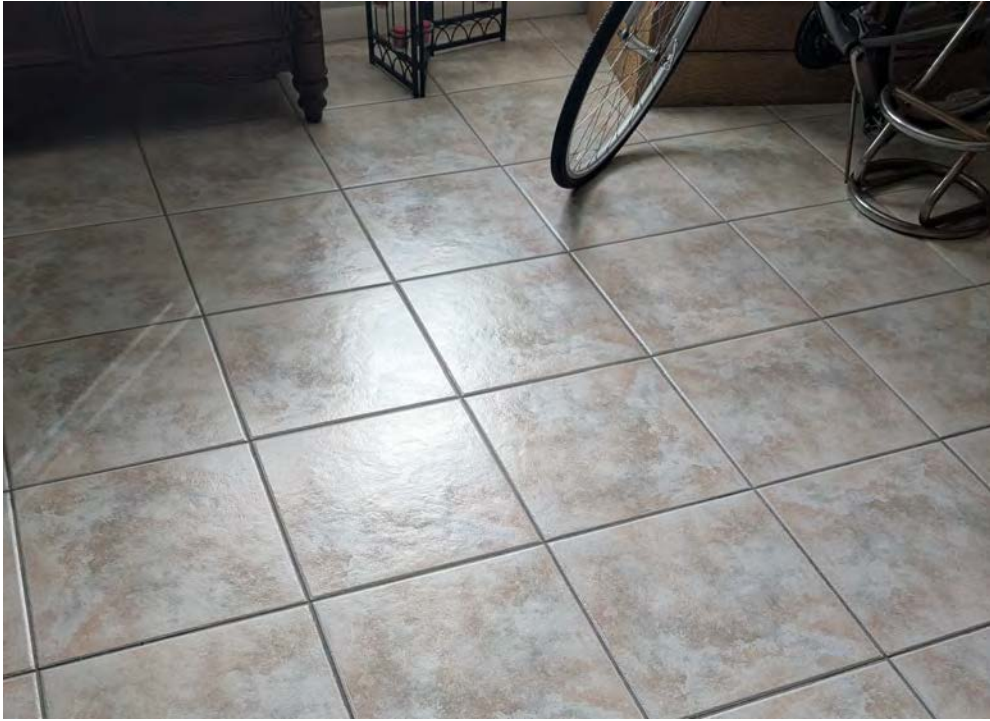
7.b.1. Type & Condition Floor System(s)

The building is reinforced concrete slab on grade (SOG) construction. The floors above grade are supported by reinforced concrete. Noted to be in good condition.

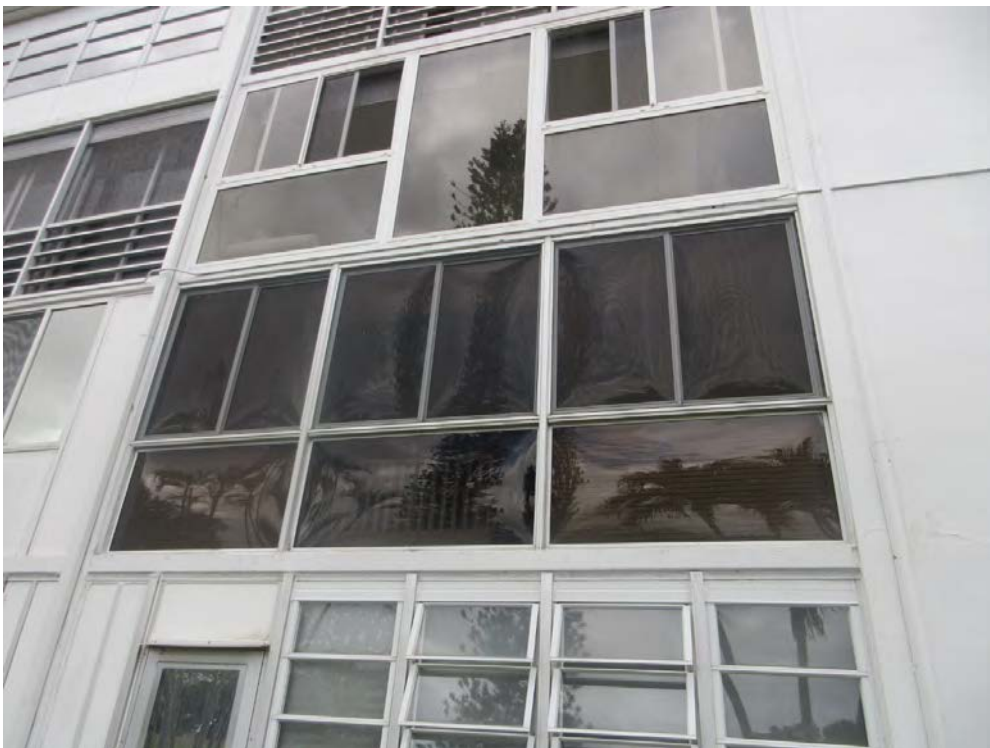
7.b.2. View of Balconies

The building is provided with reinforced concrete balconies located at the rear of the building. The reinforced concrete balconies were noted to be in good condition.

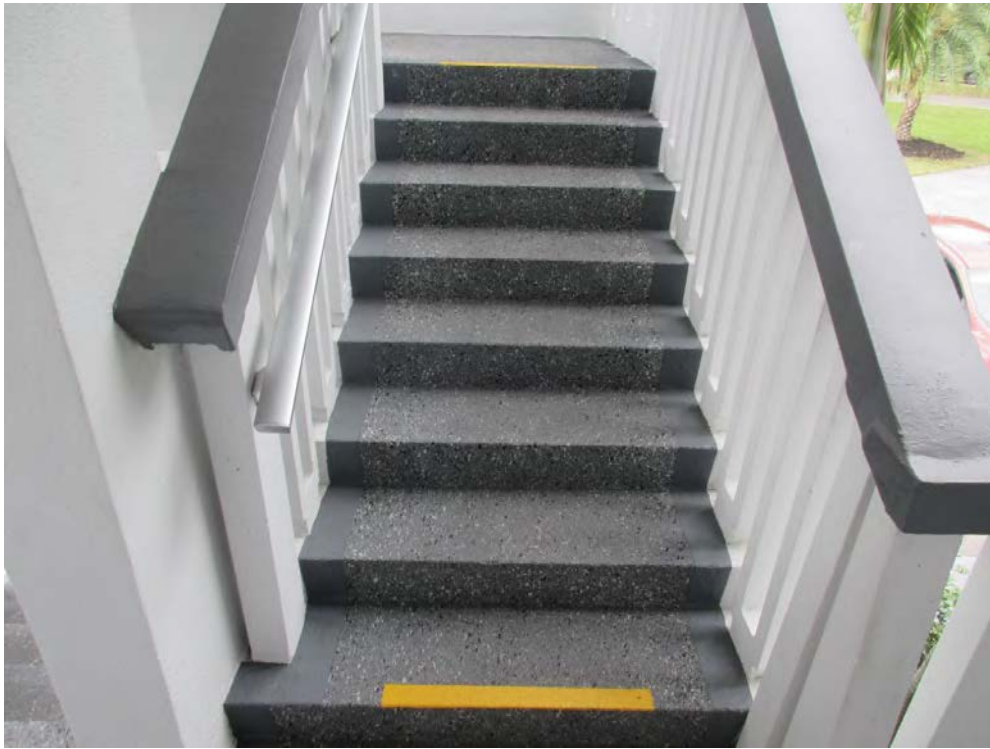
7.b.3. View of Stairs & Landings

Exterior reinforced concrete stairwells with concrete railings lead to the upper levels reinforced concrete catwalks with concrete railings. The reinforced stairwells are noted to be in good condition.

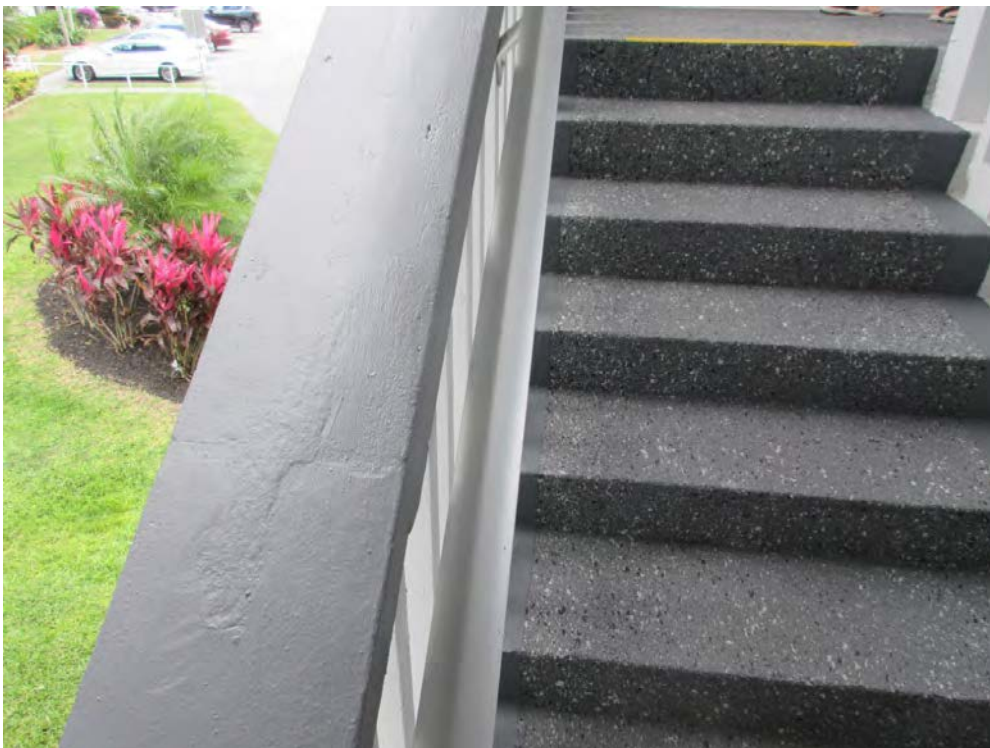
7.b.5. View of Guardrails & Handrails

The building is provided with concrete railings/guradrails for the exterior stairwells and catwalks. Noted to be in good condition.

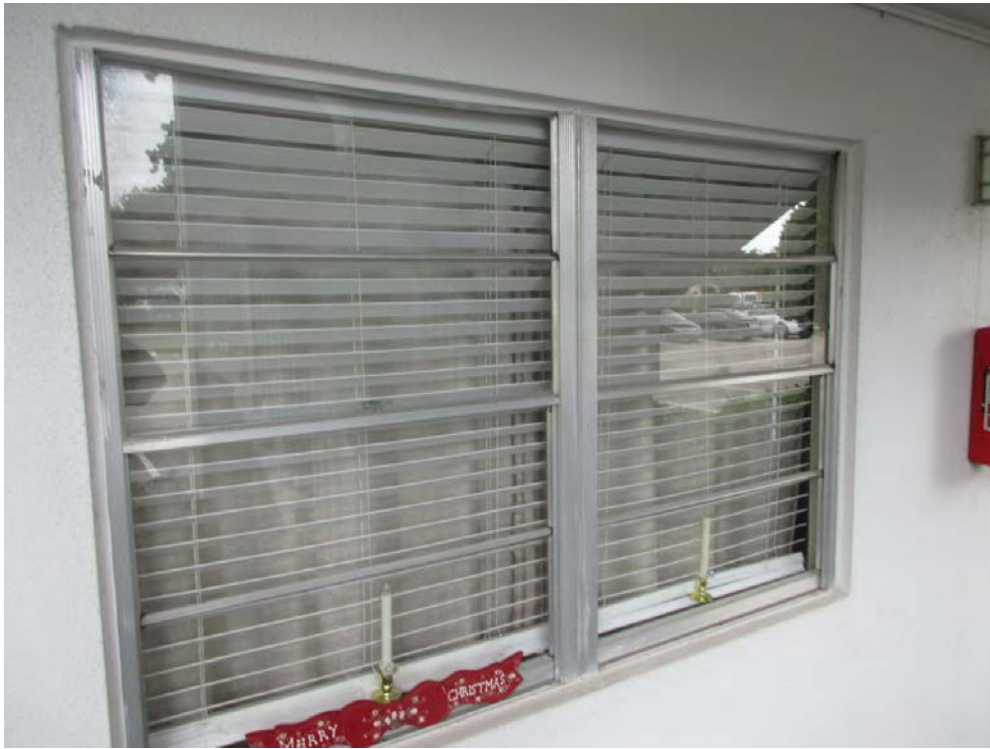
10.a. View of Windows

The building is provided with single hung, awning and horizontal slider windows set in aluminum frames.

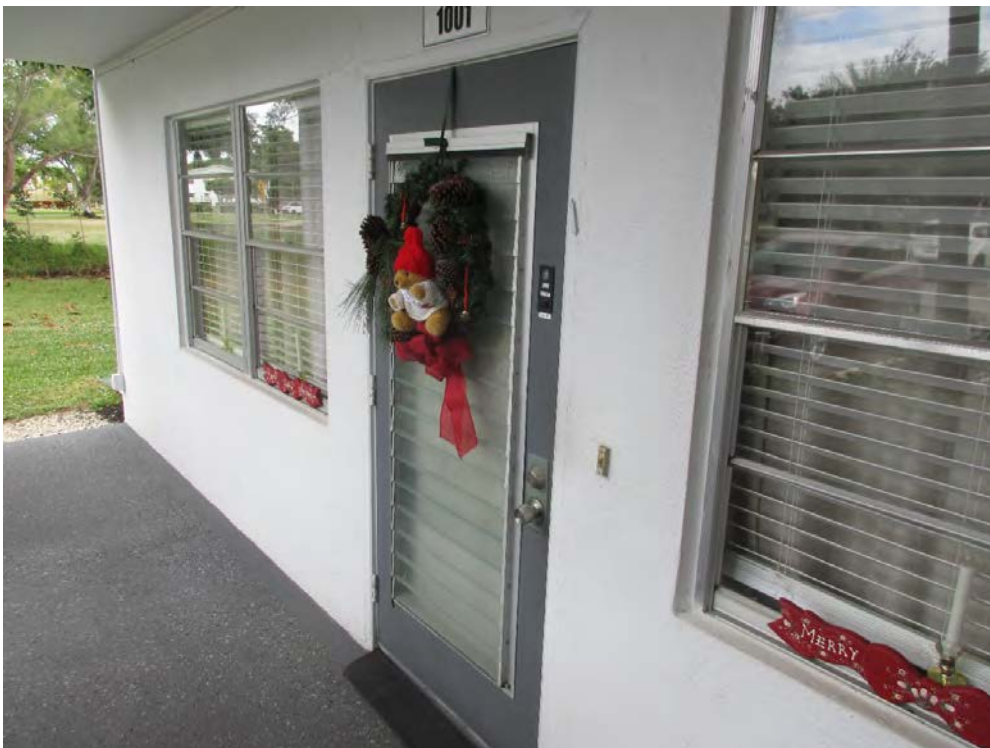
10.c.1. View of Exterior Doors

The building is provided with wood doors with jalousie window inserts set in wood frames, wood doors set in wood frames. The patios are provided with aluminum doors with glass inserts set in aluminum frames. Noted to be in good condition.

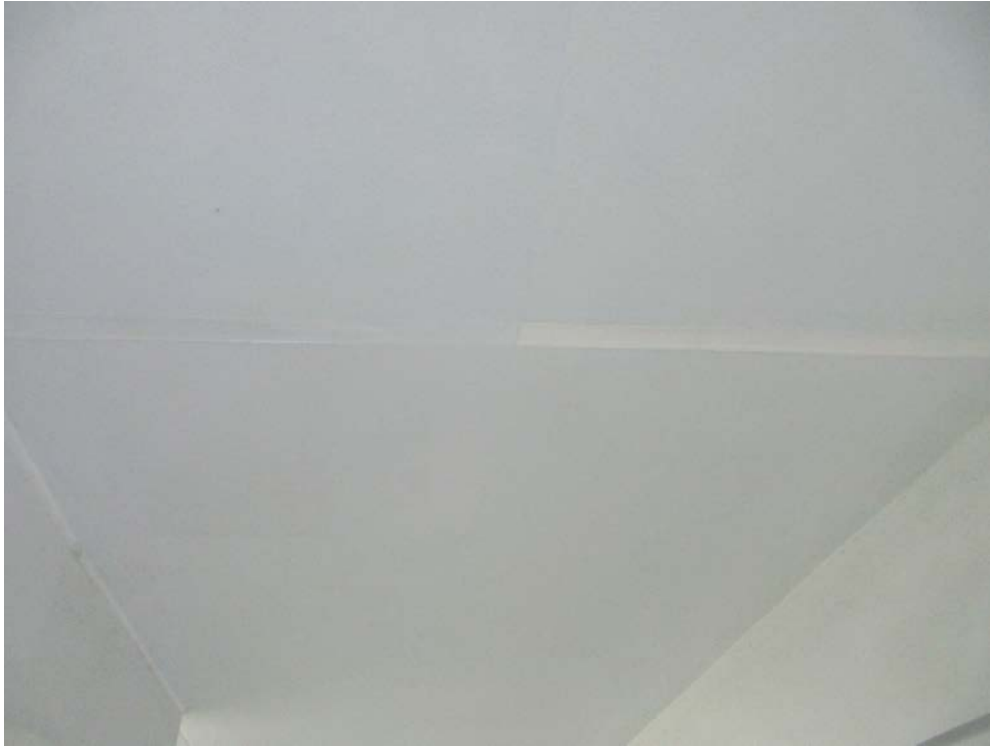
11.d. View of Joints/Seams

Joints are well fitted and still closed.

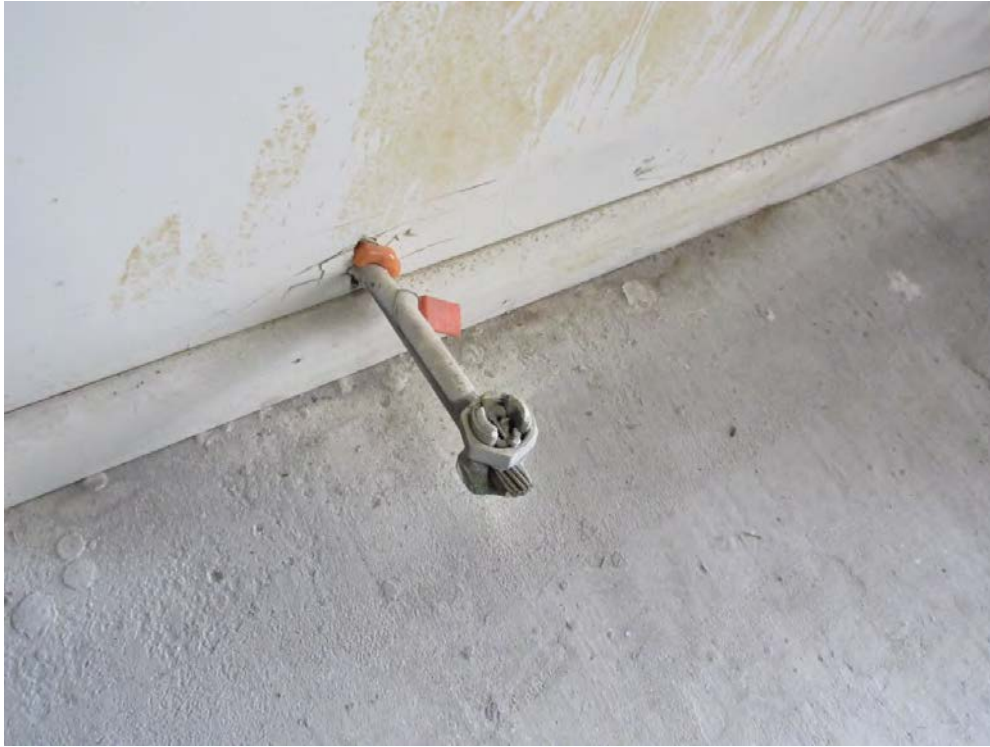
9. View of Grounding of Service

The services were noted to be bonded to grounding rods.

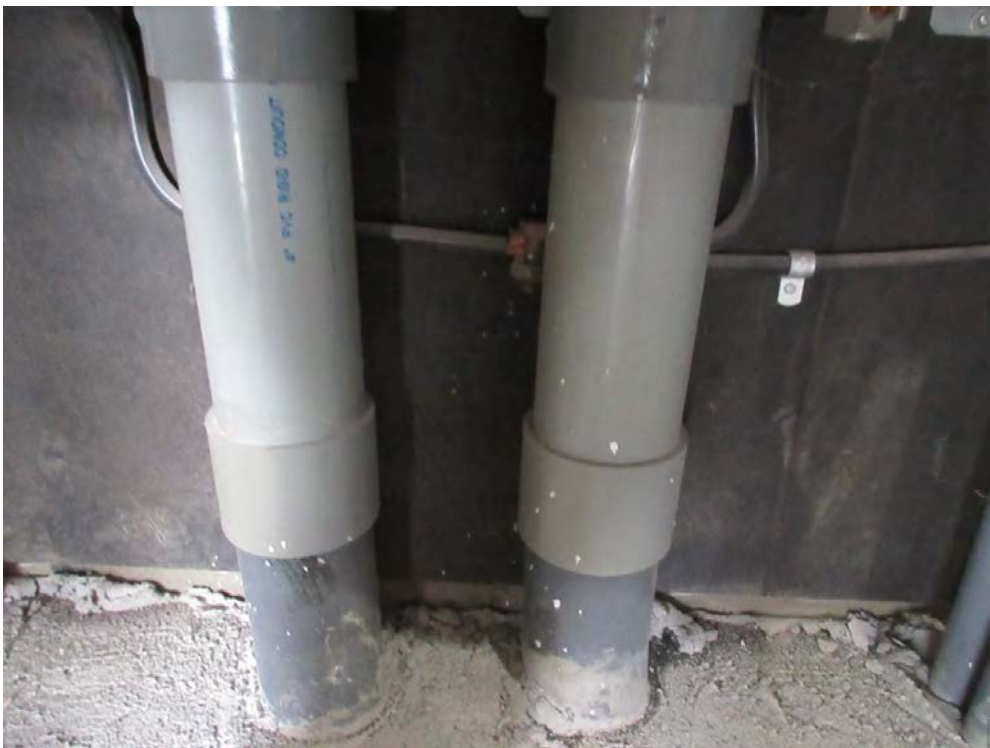
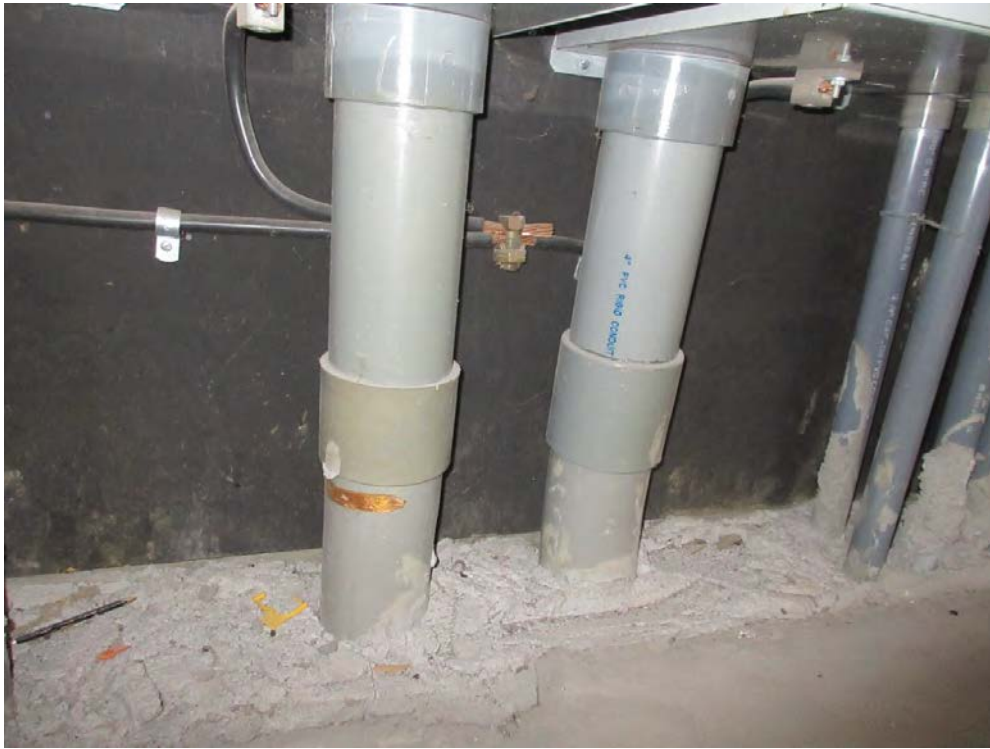
11. View of Service Conductors/Raceways

Service conduits and raceways were noted to be in good condition.

Service conductors and cables were noted to be in good condition.

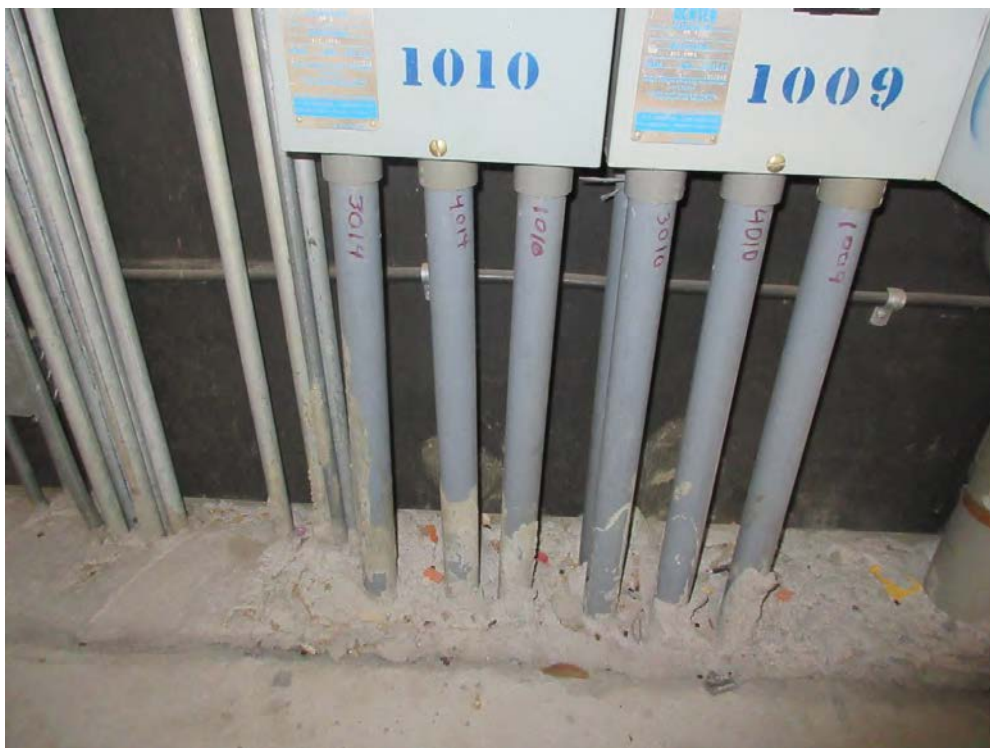
13. View of General Conduit/Raceways

General conduits and raceways were noted to be in good condition.

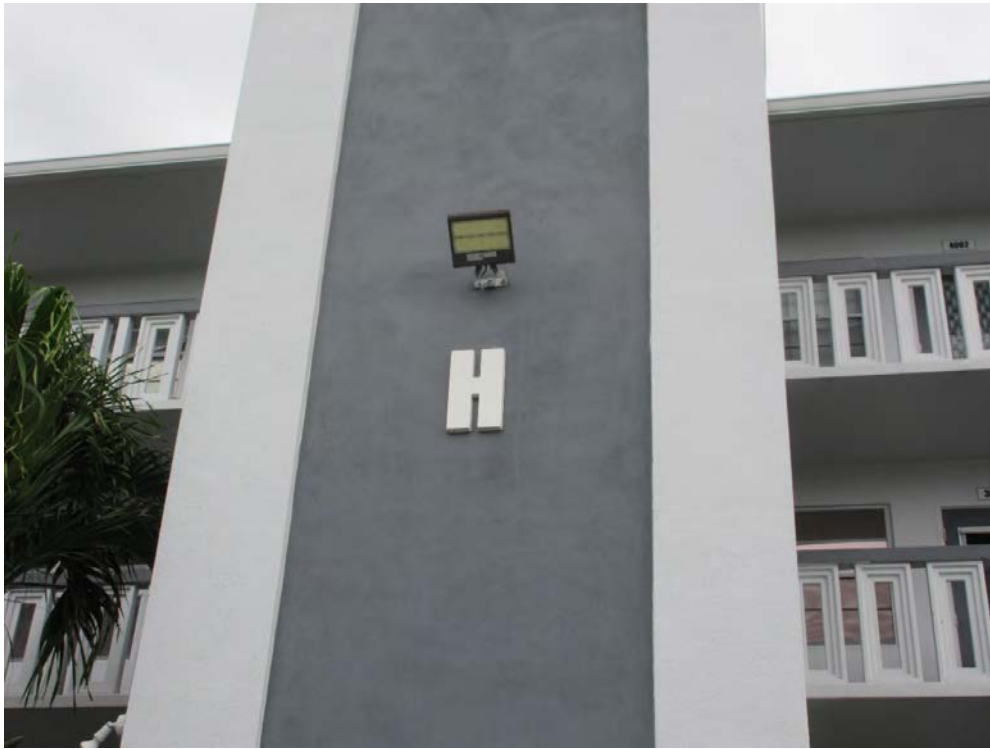
18. View of Building Egress Illumination

All egress Illumination inspected appears to be in serviceable condition.

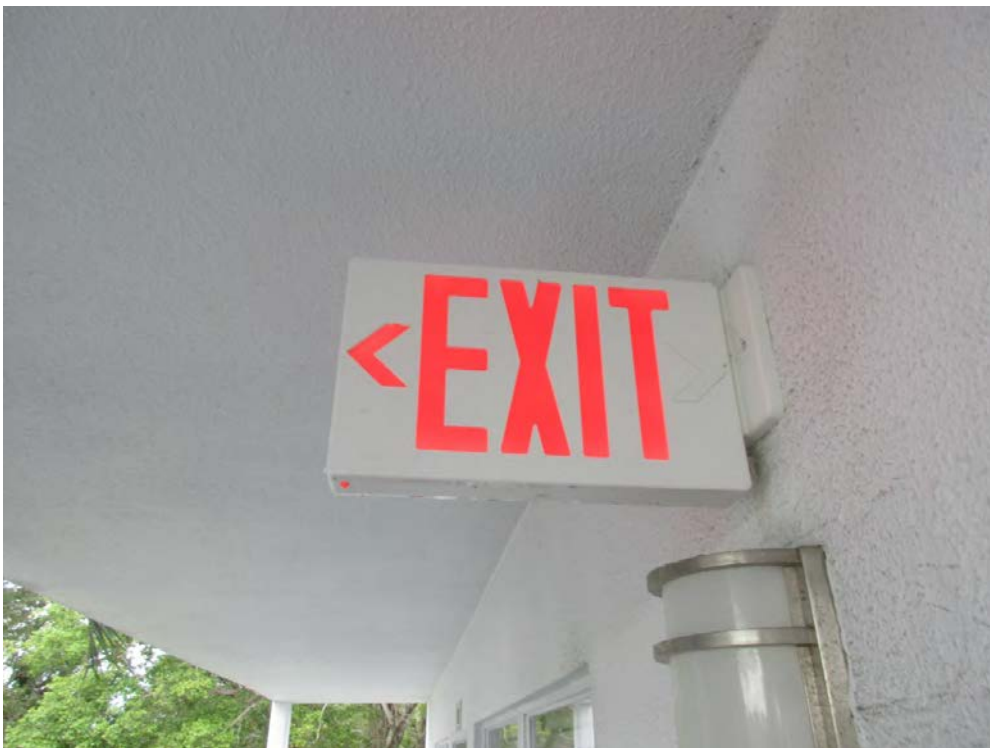
21. View of Exit Lights

All exit lights inspected appears to be in serviceable condition.
